INVESTIGATION REPORT

FIELD STRENGTH MEASUREMENTS
OF
KOKS ANTENNA PATTERN

INSPECTION NOTES
KOKS - POPLAR BLUFF, MO
2/10/92

Radio Station KOKS
Poplar Bluff, MO

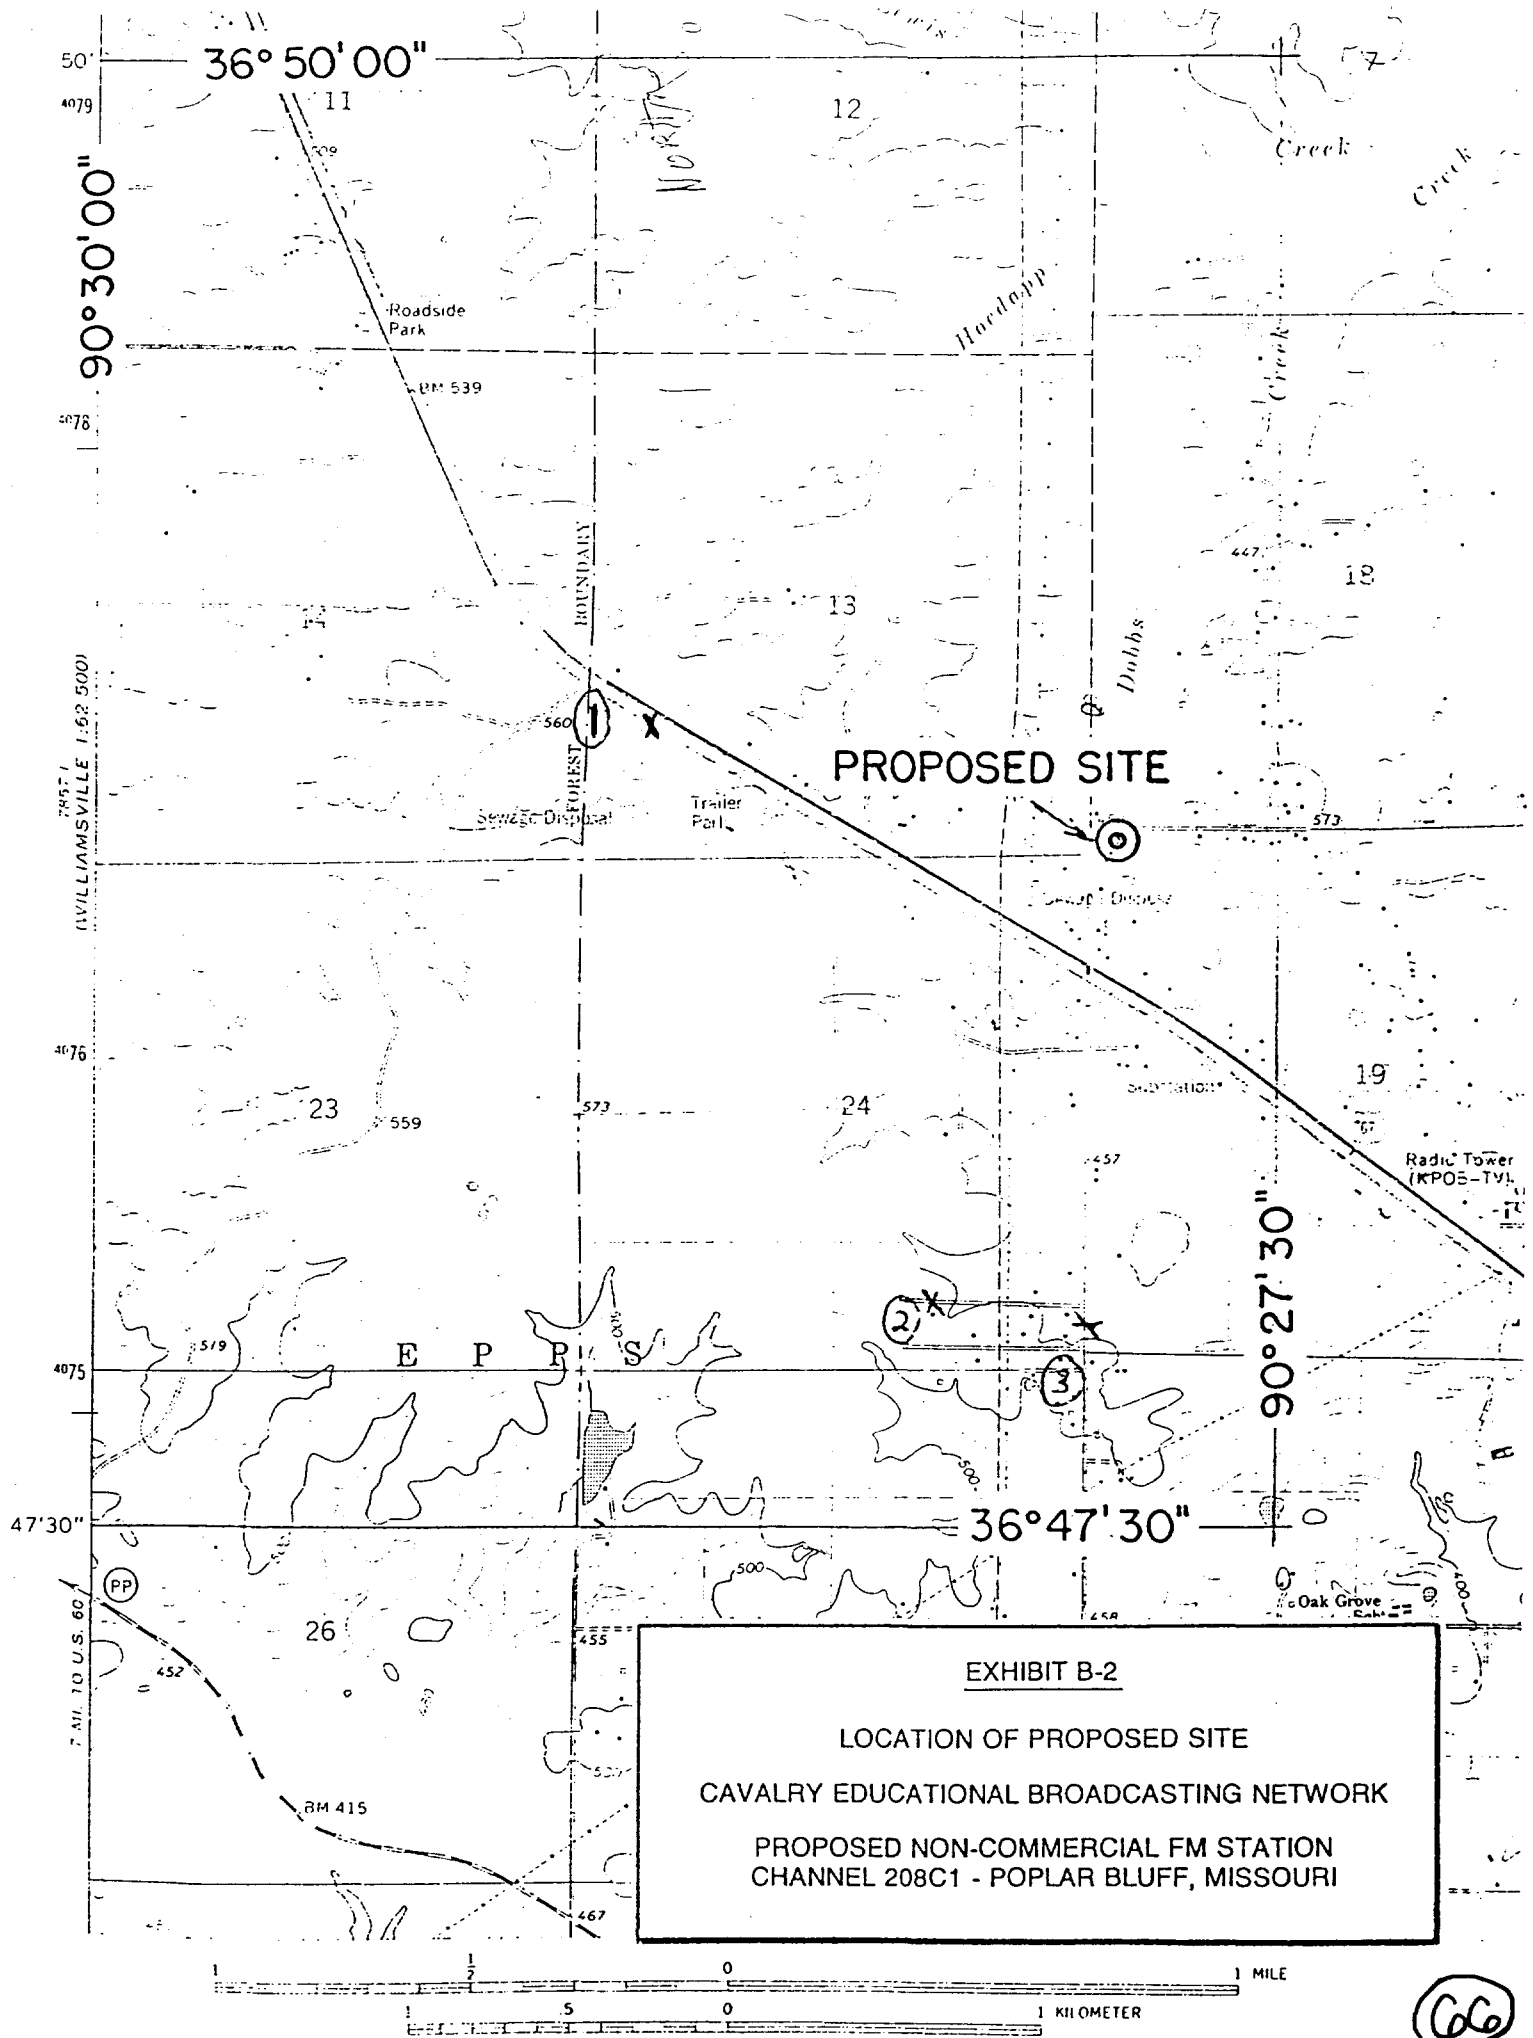
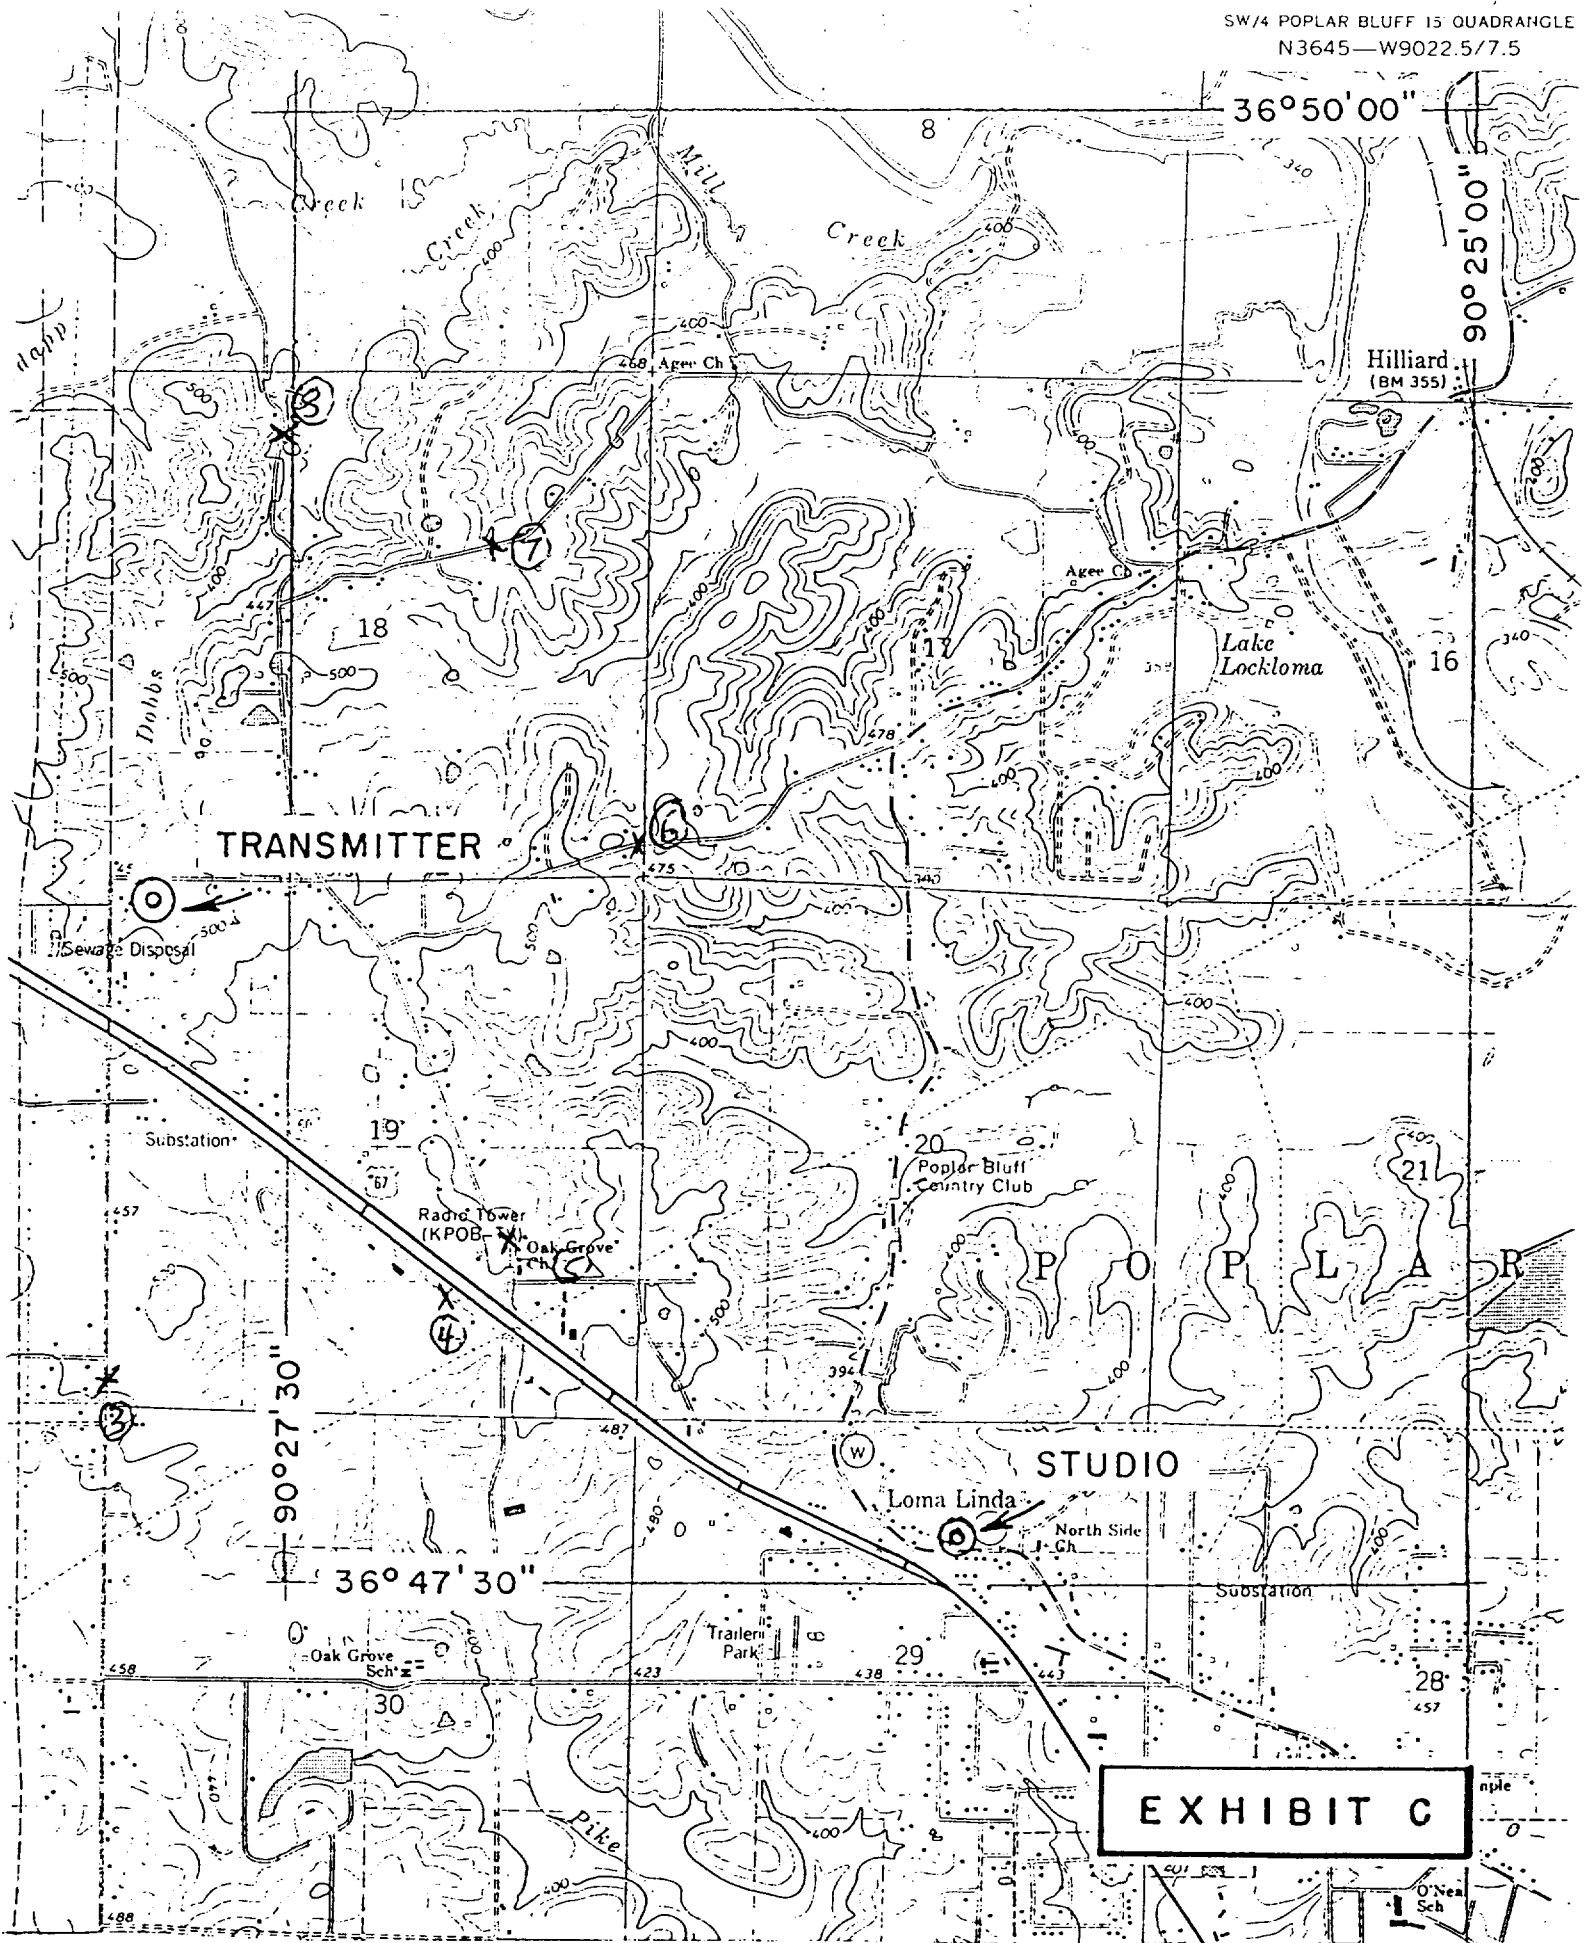
The following point #'s are associated with the corresponding points labeled on the attached maps of the area surrounding the KOKS radio tower.

POINT #	MEASUREMENT
1	505mv/m
2	505mv/m
3	1,075mv/m
4	860mv/m
5	860mv/m
6	75mv/m
7	75mv/m
8	2,150mv/m
